FM STEREO/FM-AM RECEIVER

STR-6065

SUPPLEMENT

No. 2
April, 1973

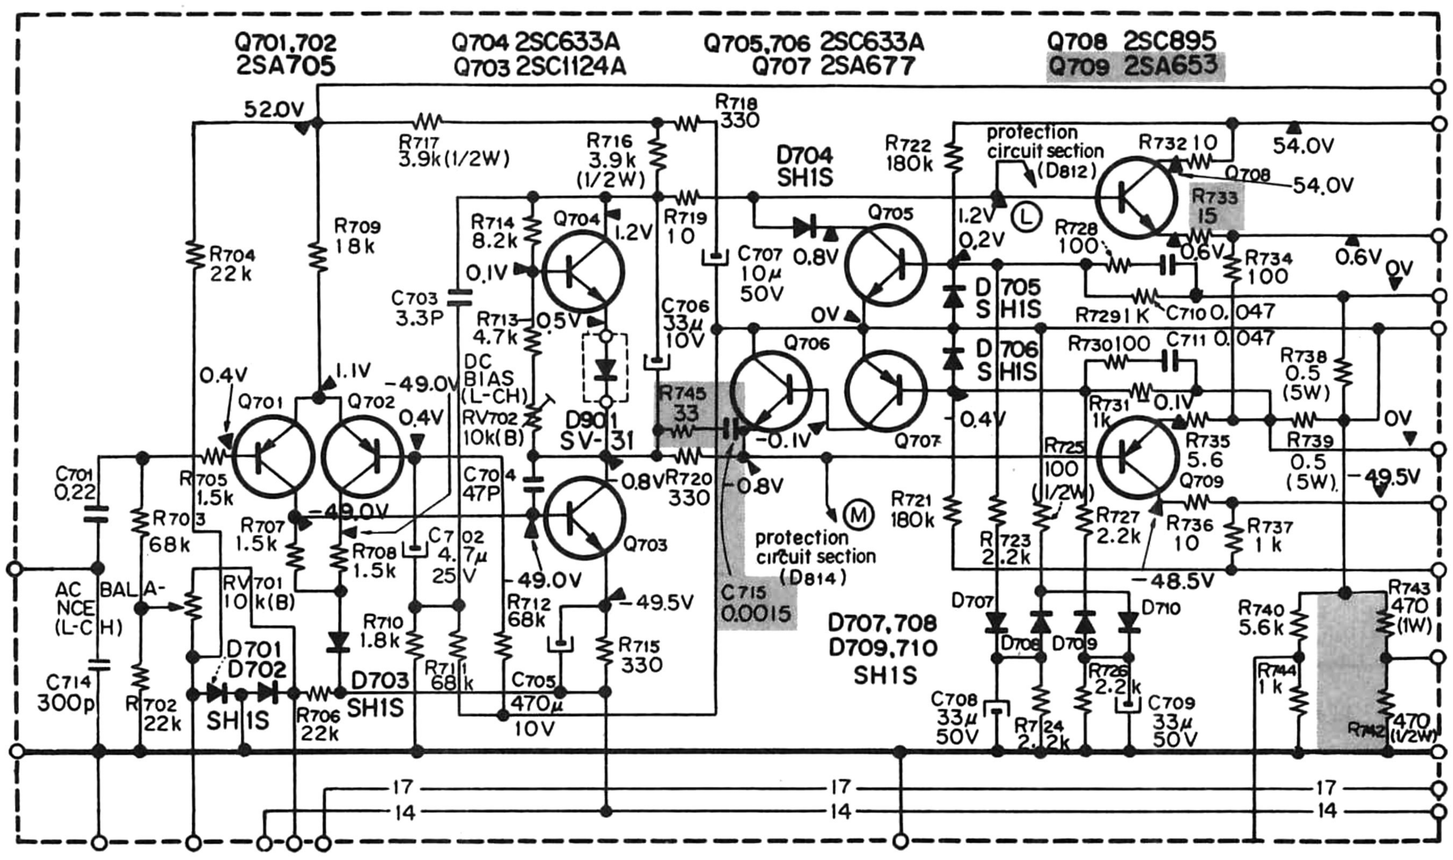
POWER AMP SECTION

The power amplifier board has been modified because transistors, Q709 and Q759, in driver stage, changed from 2SA527 to 2SA653.

: changed portion

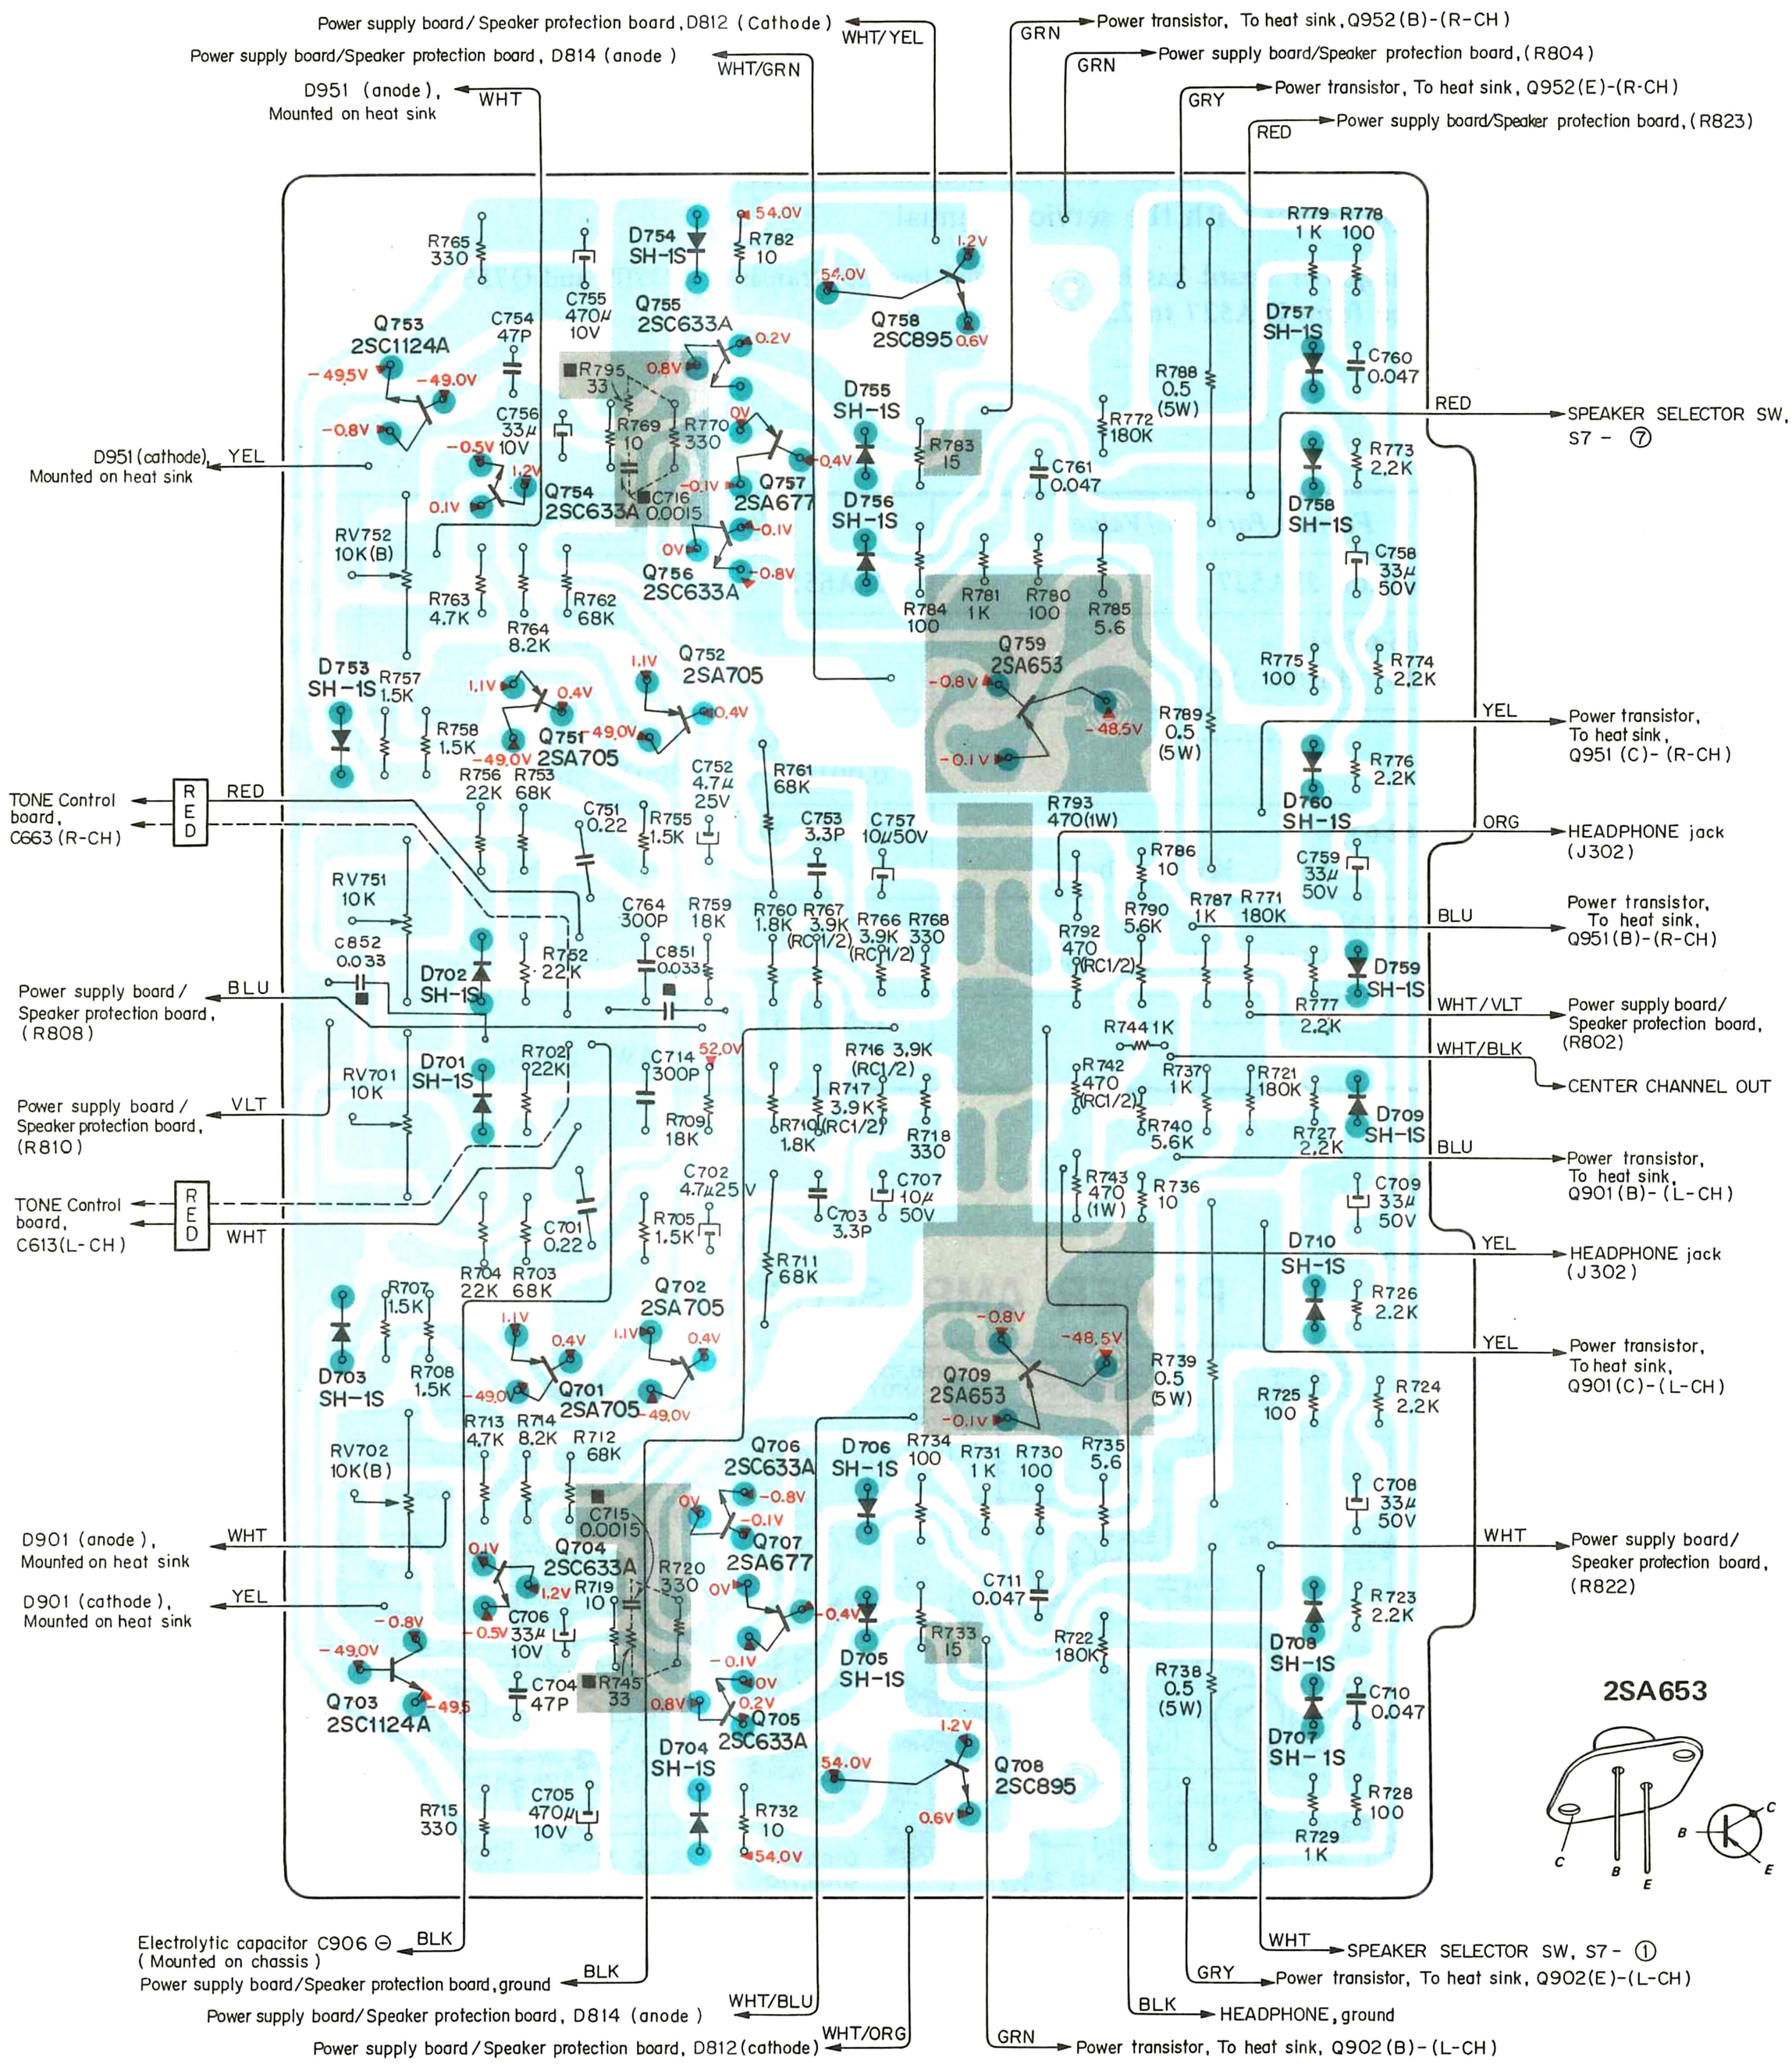
MOUNTING DIAGRAM — Power Amplifier Board —

: changed portion
